**Flood Control Project Maintenance
Levee Inspections**
LMA District Cover Sheet
Spring 2017 Levee Inspection Results

Sacramento Maintenance Yard Sacramento Bypass

Spring 2017 Levee Inspection Results

Waterway			Bank	Unit Miles
Unit No. 01 Sacramento Bypass or North Levee			Right	1.74
	Spring (March - May)	Summer (June - August)	(September - November) Fall	Winter (December - February)
Unit Maintenance Rating (Fall Only)				
Date of Inspection	4/18/2017 - 4/18/2017			
DWR Inspector	Zach Jojola			
Accompanied By	Casey Lund

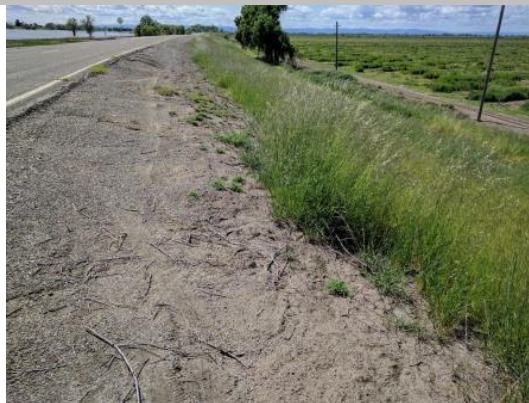
Photo 1 of 1 : SP_2017_ST0008_284_9_20170419_00014.jpg

LM Start	0.05	Rating **	U	Issue No.	9
LM End	1.73	Issue Type +	Ma	Location *	LS
Category	Earthen Levee			GPS Latitude/Longitude	
				Start	End
Item	Vegetation			38.606917 °	38.599516 °
				-121.560718 °	-121.590145 °
DWR ID	DWR_ST0008_01_s_2017_9				
Comment Code					
V1 : Control annual grass and weeds on the levee slopes and easements.					
Inspector Comment

Tall grass on the landside slope, blocking visibility. Spring 2017.

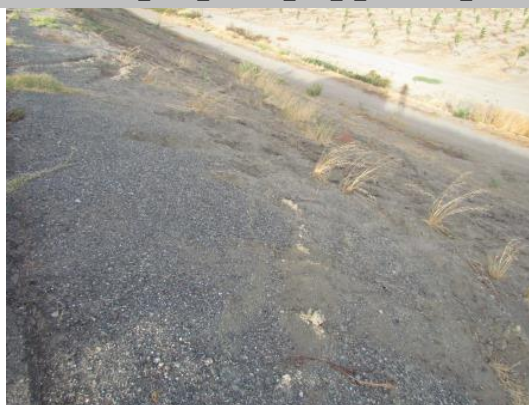
Photo 1 of 1 : SP_2017_ST0008_284_6_20170320_00001.jpg

LM Start	0.08	Rating **	M	Issue No.	6
LM End	0.08	Issue Type +	Ma	Location *	LS
Category	Earthen Levee			GPS Latitude/Longitude	
				Start	End
Item	Slope Stability			38.606622 °	38.606622 °
				-121.561266 °	-121.561266 °
DWR ID	DWR_ST0008_01_f_2016_6				
Comment Code					
S3 : Repair the levee slope damaged by vehicle traffic and prevent access where possible.					
Inspector Comment

Slope stability issue caused by vehicles. Fall 2016.

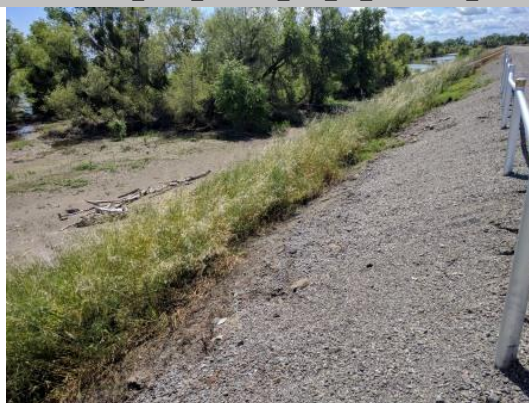
Photo 1 of 1 : SP_2017_ST0008_284_11_20170419_00015.jpg

LM Start	0.41	Rating **	U	Issue No.	11
LM End	1.73	Issue Type +	Ma	Location *	WS
Category	Earthen Levee			GPS Latitude/Longitude	
				Start	End
Item	Vegetation			38.605003 °	38.599516 °
				-121.566835 °	-121.590145 °
DWR ID	DWR_ST0008_01_s_2017_11				
Comment Code					
V1 : Control annual grass and weeds on the levee slopes and easements.					
Inspector Comment

Tall grass on waterside slope, blocking visibility. Spring 2017.

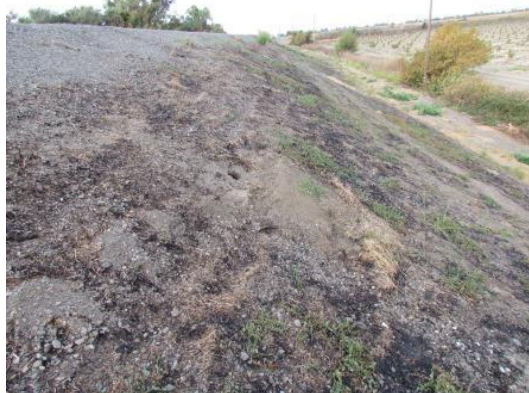
Photo 1 of 2 : SP_2017_ST0008_284_10_20170320_00003.jpg

LM Start	0.94	Rating **	A/W	Issue No.	10
LM End	0.94	Issue Type +	Ma	Location *	LS
Category	Earthen Levee			GPS Latitude/Longitude	
				Start	End
Item	Animal Control			38.602763 °	38.602763 °
				-121.576288 °	-121.576288 °
DWR ID	DWR_ST0008_01_f_2015_10				
Comment Code					
A3 : No rodents visible, but rodent burrows visible; need to backfill and compact or grout burrows.					
Inspector Comment

An updated view of the rodent holes on LS slope. Fall 2016.

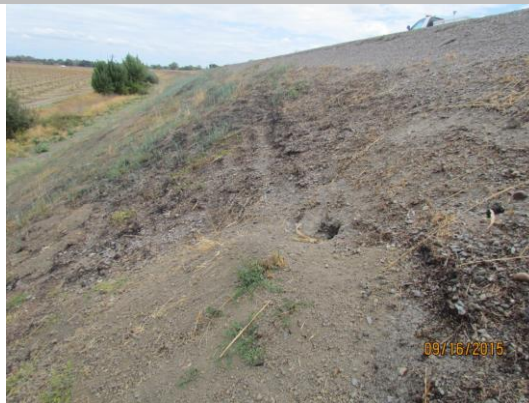
Photo 2 of 2 : SP_2017_ST0008_284_10_20170320_00004.jpg

View of the rodent holes on the landward side of the levee looking upstream. Fall 2015.

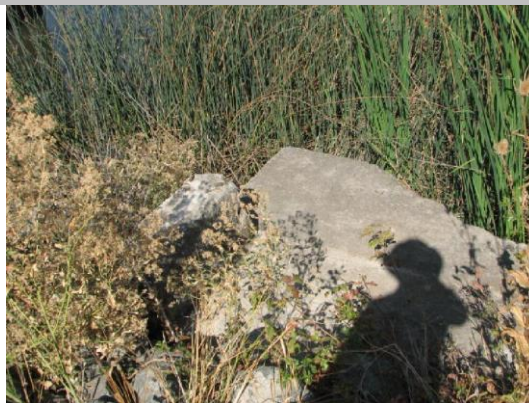
Photo 2 of 3 : UCIP_SP_2017_44787_20604.jpg

LM Start	1.09	Rating **	A/W	Issue No.	16
LM End	1.09	Issue Type +	Ma	Location *	LS
Category	Supplemental			GPS Latitude/Longitude	
				Start	End
Item	DWR UCIP LMA Responsibility			38.602169°	38.602169°
				-121.579000°	-121.579000°
DWR ID					
Comment Code					
Inspector Comment					
FS_ID:44787					
DS_ID:19076					
EP_NO: N/A					
Repair Type: No Action Needed					
Crossing Status: Found					
UCIP Comments: A concrete saddle found on slough/drainage. No pump was found on LS and no structure/pipe found on WS.					
FIELD_STRUCT_DESC: An abandoned grouted 36-inch CM pipe.					
Remaing of concrete structure found on LS.O&M Manual Sac 122.1, August 1955, Revision Year 2011.					
FS Date: 4/28/2015 2:44:05 PM

Landside view: remaining of concrete structure

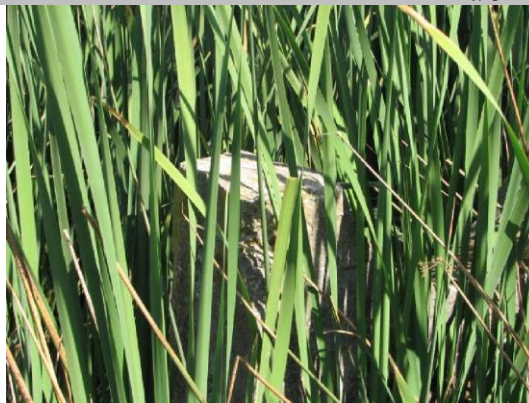
Photo 3 of 3 : UCIP_SP_2017_44787_20606.jpg

LM Start	1.09	Rating **	A/W	Issue No.	16 (cont)
LM End	1.09	Issue Type +	Ma	Location *	LS
Category	Supplemental			GPS Latitude/Longitude	
				Start	End
Item	DWR UCIP LMA Responsibility			38.602169 °	38.602169 °
				-121.579000 °	-121.579000 °
DWR ID					
Comment Code					
Inspector Comment					
FS_ID:44787					
DS_ID:19076					
EP_NO: N/A					
Repair Type: No Action Needed					
Crossing Status: Found					
UCIP Comments: A concrete saddle found on slough/drainage. No pump was found on LS and no structure/pipe found on WS.					
FIELD_STRUCT_DESC: An abandoned grouted 36-inch CM pipe.					
Remaing of concrete structure found on LS.O&M Manual Sac 122.1, August 1955, Revision Year 2011.					
FS Date: 4/28/2015 2:44:05 PM

Landside view: remaining of concrete structure on drainage/slough

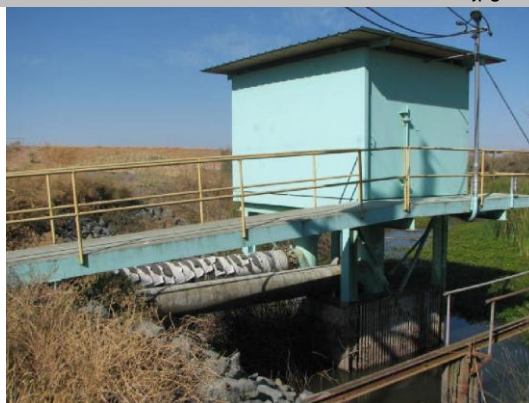
Photo 1 of 3 : UCIP_SP_2017_44783_20611.jpg

LM Start	1.10	Rating **	M	Issue No.	17
LM End	1.10	Issue Type +	En	Location *	LS
Category	Supplemental			GPS Latitude/Longitude	
				Start	End
Item	DWR UCIP Field Study			38.602180 °	38.602180 °
				-121.579130 °	-121.579130 °
DWR ID					
Comment Code					
Inspector Comment					
FS_ID:44783 DS_ID:19066 EP_NO: 13616 Repair Type: Non-Urgent Crossing Status: Found UCIP Comments: After more investigation depressions are from water run off. erosion repair needed FIELD_STRUCT_DESC: 1 of 2. A agriculture drainage pumping system with 24-inch and 20-inch steel discharge pipelines through the north levee of the Sacramento Bypass. The pipe is 6.33 ft below the crown and a siphon breaker on the WS. Vertical GI pipe trash rack on inlet structure. Application no. 13616, 1995 (revised). FS Date: 4/28/2015 2:43:01 PM

Landside view: pumping plant overview

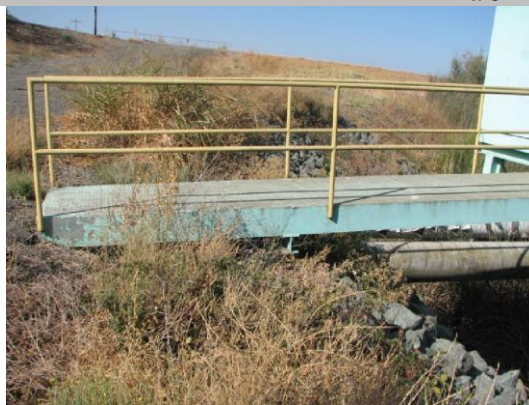
Photo 3 of 3 : UCIP_SP_2017_44783_20608.jpg

LM Start	1.10	Rating **	M	Issue No.	17 (cont)	
LM End	1.10	Issue Type +	En	Location *	LS	
Category	Supplemental			GPS Latitude/Longitude		
				Start		End
Item	DWR UCIP Field Study			38.602180 °		38.602180 °
				-121.579130 °		-121.579130 °
DWR ID						
Comment Code						
Inspector Comment						
FS_ID:44783 DS_ID:19066 EP_NO: 13616 Repair Type: Non-Urgent Crossing Status: Found UCIP Comments: After more investigation depressions are from water run off. erosion repair needed FIELD_STRUCT_DESC: 1 of 2. A agriculture drainage pumping system with 24-inch and 20-inch steel discharge pipelines through the north levee of the Sacramento Bypass. The pipe is 6.33 ft below the crown and a siphon breaker on the WS. Vertical GI pipe trash rack on inlet structure. Application no. 13616, 1995 (revised). FS Date: 4/28/2015 2:43:01 PM

Landside view: walkway to the pump house.

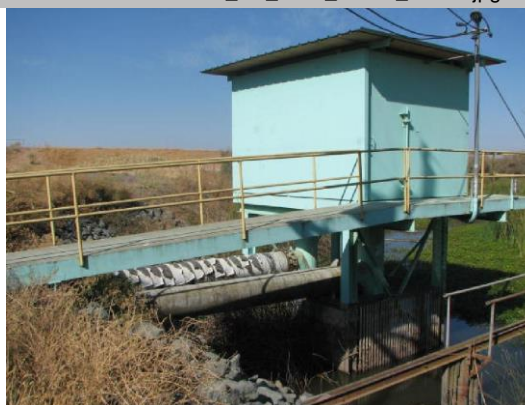
Photo 1 of 3 : UCIP_SP_2017_44784_20619.jpg

LM Start	1.10	Rating **	M	Issue No.	18
LM End	1.10	Issue Type +	En	Location *	WS
Category	Supplemental			GPS Latitude/Longitude	
				Start	End
Item	DWR UCIP Field Study			38.602128 °	38.602128 °
				-121.579150 °	-121.579150 °
DWR ID					
Comment Code					
Inspector Comment					
FS_ID:44784 DS_ID:19079 EP_NO: 13616 Repair Type: Non-Urgent Crossing Status: Found UCIP Comments: Horizontal Air vent on waterside slope. Green vegetation and depressions also found on waterside slope. FIELD_STRUCT_DESC: 2 of 2. A agricultural drainage pumping system with 24-inch and 20-inch steel discharge pipelines through the north levee of the Sacramento Bypass. The pipe is 6.33 ft below the crown and a siphon breaker on the WS. Vertical GI pipe trash rack on inlet structure. Application no. 13616, 1995 (revised). FS Date: 4/28/2015 2:43:26 PM

Landside view: overview of pumping plant

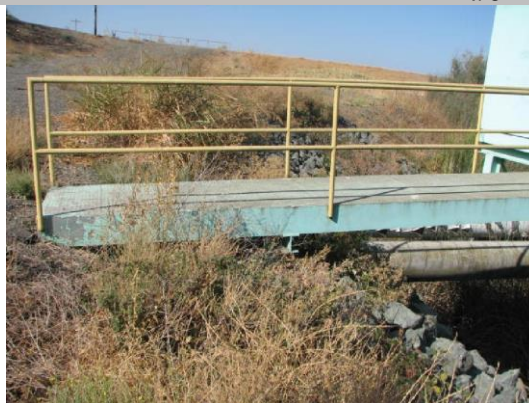
Photo 2 of 3 : UCIP_SP_2017_44784_20618.jpg

LM Start	1.10	Rating **	M	Issue No.	18 (cont)	
LM End	1.10	Issue Type +	En	Location *	WS	
Category	Supplemental			GPS Latitude/Longitude		
				Start	End	
Item	DWR UCIP Field Study			38.602128 °	38.602128 °	
				-121.579150 °	-121.579150 °	
DWR ID						
Comment Code						
Inspector Comment						
FS_ID:44784 DS_ID:19079 EP_NO: 13616 Repair Type: Non-Urgent Crossing Status: Found UCIP Comments: Horizontal Air vent on waterside slope. Green vegetation and depressions also found on waterside slope. FIELD_STRUCT_DESC: 2 of 2. A agricultural drainage pumping system with 24-inch and 20-inch steel discharge pipelines through the north levee of the Sacramento Bypass. The pipe is 6.33 ft below the crown and a siphon breaker on the WS. Vertical GI pipe trash rack on inlet structure. Application no. 13616, 1995 (revised). FS Date: 4/28/2015 2:43:26 PM

Landside view: walkway to the pumping plant

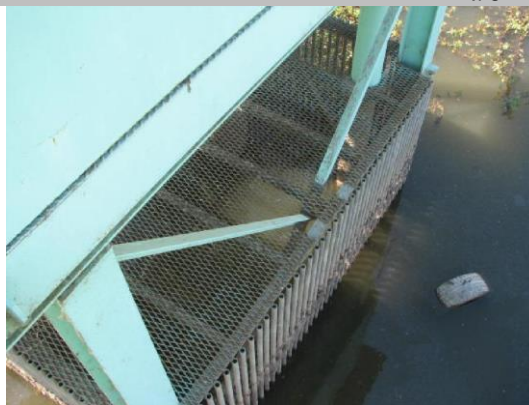
Photo 3 of 3 : UCIP_SP_2017_44784_20617.jpg

Landside view: vertical GI pipe trash rack in inlet structure.

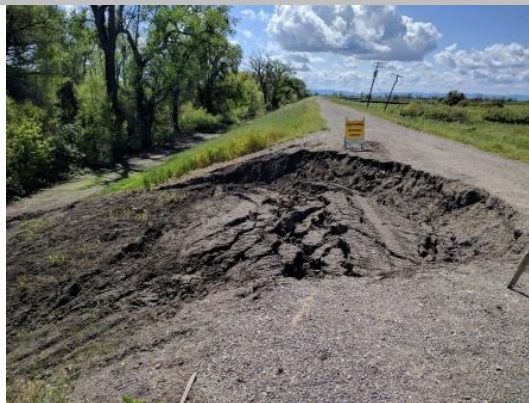
Photo 1 of 1 : SP_2017_ST0008_284_12_20170419_00016.jpg

LM Start	1.22	Rating **	M	Issue No.	12
LM End	1.22	Issue Type +	Ma	Location *	WS
Category	Earthen Levee			GPS Latitude/Longitude	
				Start	End
Item	Slope Stability			38.601606 °	38.601606 °
				-121.581240 °	-121.581240 °
DWR ID	DWR_ST0008_01_s_2017_12				
Comment Code					
S1 : Repair slope instability.					
Inspector Comment					
Large sloughing site on waterside levee slope and crown.

View of sloughing on waterside levee slope and crown. Spring 2017.

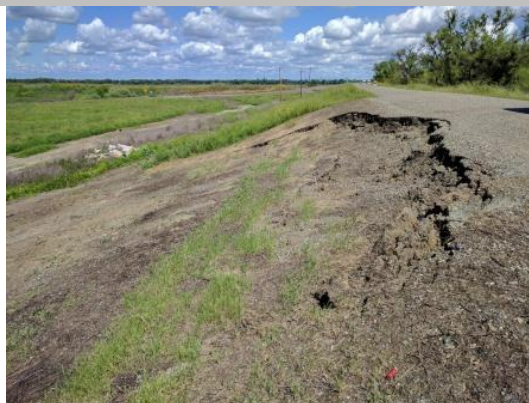
Photo 1 of 1 : SP_2017_ST0008_284_13_20170419_00017.jpg

LM Start	1.28	Rating **	M	Issue No.	13
LM End	1.28	Issue Type +	Ma	Location *	LS
Category	Earthen Levee			GPS Latitude/Longitude	
				Start	End
Item	Slope Stability			38.601325 °	38.601325 °
				-121.582177 °	-121.582177 °
DWR ID	DWR_ST0008_01_s_2017_13				
Comment Code					
S1 : Repair slope instability.					
Inspector Comment					
Sloughing on landside levee slope.

View of sloughing on landside levee slope. Spring 2017.

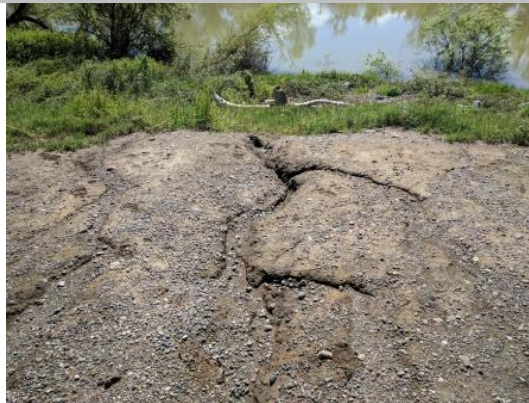
Photo 1 of 1 : SP_2017_ST0008_284_15_20170419_00019.jpg

LM Start	1.74	Rating **	M	Issue No.	15
LM End	1.74	Issue Type +	Ma	Location *	WS
Category	Earthen Levee			GPS Latitude/Longitude	
				Start	End
Item	Erosion / Bank Caving			38.599546°	38.599546°
				-121.590235°	-121.590235°
DWR ID	DWR_ST0008_01_s_2017_15				
Comment Code					
E2 : Schedule repair of erosion site prior to the next inspection.					
Inspector Comment					
Runoff erosion on waterside levee slope.

View of erosion on waterside slope. Spring 2017.

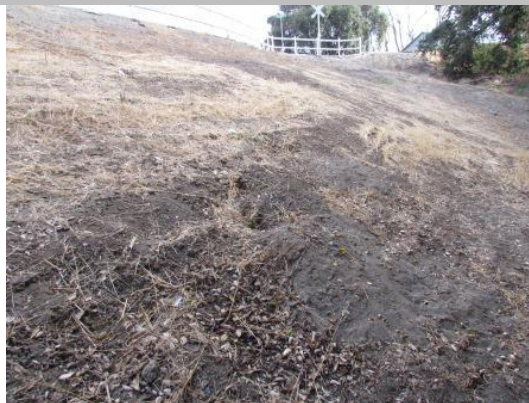
Photo 1 of 1 : SP_2017_ST0008_285_2_20170320_00001.jpg

LM Start	0.03	Rating **	A/W	Issue No.	2
LM End	0.03	Issue Type +	Ma	Location *	LS
Category	Earthen Levee			GPS Latitude/Longitude	
				Start	End
Item	Animal Control			38.602613 °	38.602613 °
				-121.556021 °	-121.556021 °
DWR ID	DWR_ST0008_02_s _ 2016_2				
Comment Code					
A3 : No rodents visible, but rodent burrows visible; need to backfill and compact or grout burrows.					
Inspector Comment

View of rodent holes on LS slope of the levee near entry gate. Fall 2016..

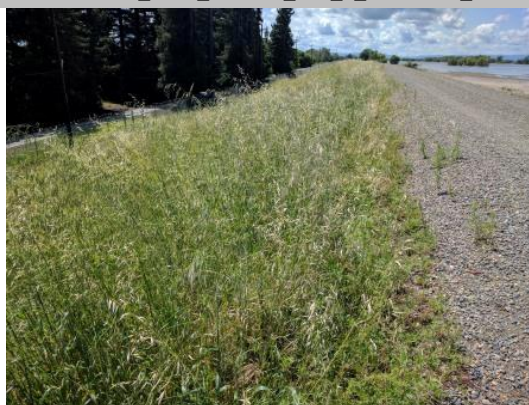
Photo 1 of 1 : SP_2017_ST0008_285_1_20170419_00007.jpg

LM Start	0.03	Rating **	U	Issue No.	1
LM End	1.77	Issue Type +	Ma	Location *	LS
Category	Earthen Levee			GPS Latitude/Longitude	
				Start	End
Item	Vegetation			38.602607 °	38.594797 °
				-121.556077 °	-121.586479 °
DWR ID	DWR_ST0008_02_s _ 2017_1				
Comment Code					
V1 : Control annual grass and weeds on the levee slopes and easements.					
Inspector Comment

Tall grass on landside levee slope, blocking visibility. Spring 2017.

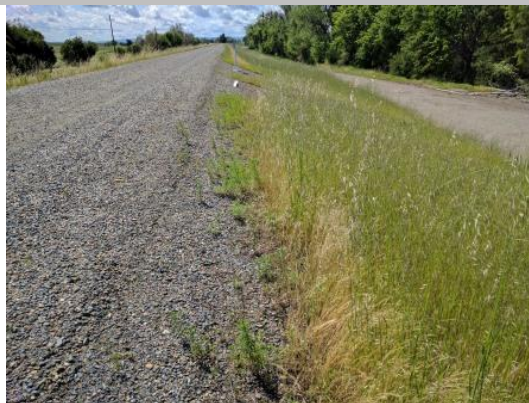
Photo 1 of 1 : SP_2017_ST0008_285_3_20170419_00008.jpg

LM Start	0.51	Rating **	U	Issue No.	3
LM End	1.14	Issue Type +	Ma	Location *	WS
Category	Earthen Levee			GPS Latitude/Longitude	
				Start	End
Item	Vegetation			38.600333 °	38.597757 °
				-121.564416 °	-121.575579 °
DWR ID	DWR_ST0008_02_s _ 2017_3				
Comment Code					
V1 : Control annual grass and weeds on the levee slopes and easements.					
Inspector Comment

Tall grass on waterside levee slope, blocking visibility. Spring 2017.

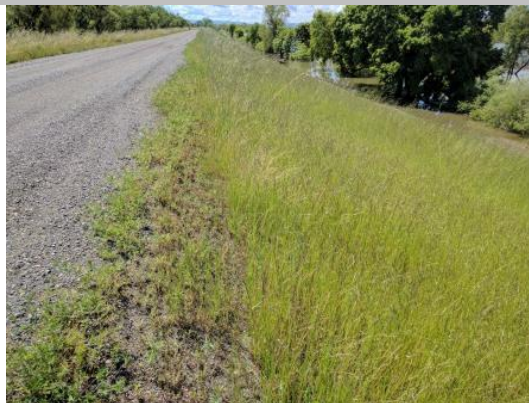
Photo 1 of 1 : SP_2017_ST0008_285_4_20170424_00011.jpg

LM Start	1.24	Rating **	U	Issue No.	4
LM End	1.77	Issue Type +	Ma	Location *	WS
Category	Earthen Levee			GPS Latitude/Longitude	
				Start	End
Item	Vegetation			38.597328 °	38.594797 °
				-121.577406 °	-121.586479 °
DWR ID	DWR_ST0008_02_s_2017_4				
Comment Code					
V1 : Control annual grass and weeds on the levee slopes and easements.					
Inspector Comment

Tall grass on waterside levee slope, blocking visibility. Spring 2017.

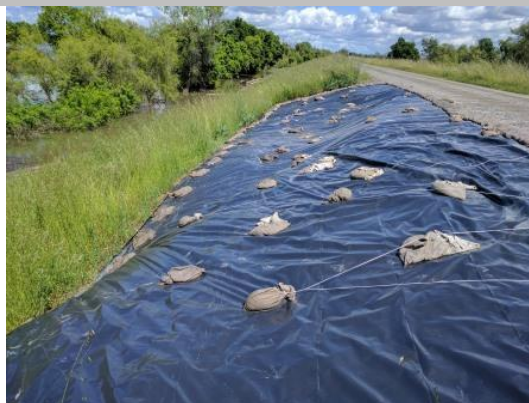
Photo 1 of 1 : SP_2017_ST0008_285_6_20170419_00009.jpg

LM Start	1.36	Rating **	M	Issue No.	6
LM End	1.36	Issue Type +	Ma	Location *	WS
Category	Earthen Levee			GPS Latitude/Longitude	
				Start	End
Item	Slope Stability			38.596772 °	38.596772 °
				-121.579336 °	-121.579336 °
DWR ID	DWR_ST0008_02_s_2017_6				
Comment Code					
S1 : Repair slope instability.					
Inspector Comment					
100' slough section on waterside levee slope.

View of sloughing on waterside levee slope. LMA placed visqueen on slope to prevent further damage from occurring. Spring 2017.

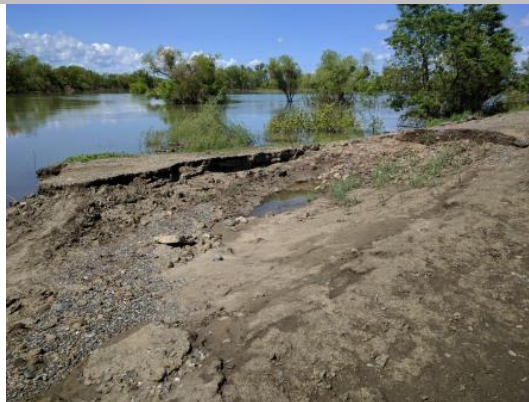
Photo 1 of 1 : SP_2017_ST0008_285_8_20170419_00010.jpg

LM Start	1.77	Rating **	M	Issue No.	8
LM End	1.77	Issue Type +	Ma	Location *	WS
Category	Earthen Levee			GPS Latitude/Longitude	
				Start	End
Item	Erosion / Bank Caving			38.594710 °	38.594710 °
				-121.586582 °	-121.586582 °
DWR ID	DWR_ST0008_02_s_2017_8				
Comment Code					
E2 : Schedule repair of erosion site prior to the next inspection.					
Inspector Comment

View of erosion on waterside levee slope. Spring 2017.

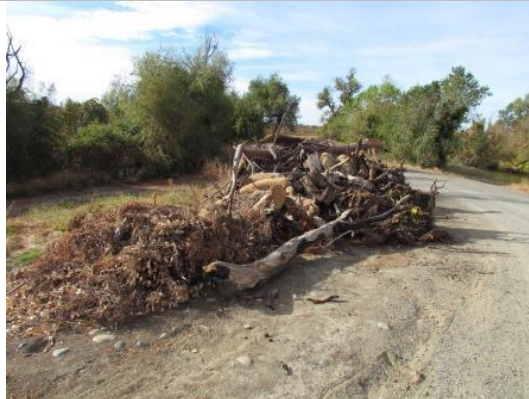
Photo 1 of 2 : SP_2017_ST0008_285_5_20170320_00002.jpg

LM Start	1.78	Rating **	M	Issue No.	5
LM End	1.78	Issue Type +	Ma	Location *	LS
Category	Earthen Levee			GPS Latitude/Longitude	
				Start	End
Item	Encroachments			38.594702 °	38.594702 °
				-121.586604 °	-121.586604 °
DWR ID	DWR_ST0008_02_s_2016_5				
Comment Code					
PR : Prunings					
Inspector Comment					
This is a seasonal pile but gets burned by the LMA each year.

More debris was added to the pile since the time of last inspection. Fall 2016.

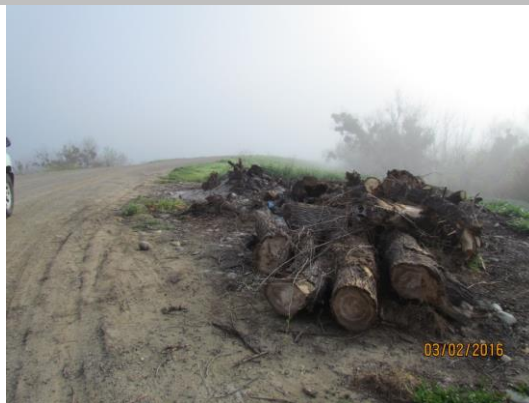
Photo 2 of 2 : SP_2017_ST0008_285_5_20170320_00003.jpg

View of the firewood on the landward side of the levee looking upstream. Spring 2016.
